National Inspection Services

Report: 284854

VIN: 1NKZX4EX2MJ432202

2021 KENWORTH T880

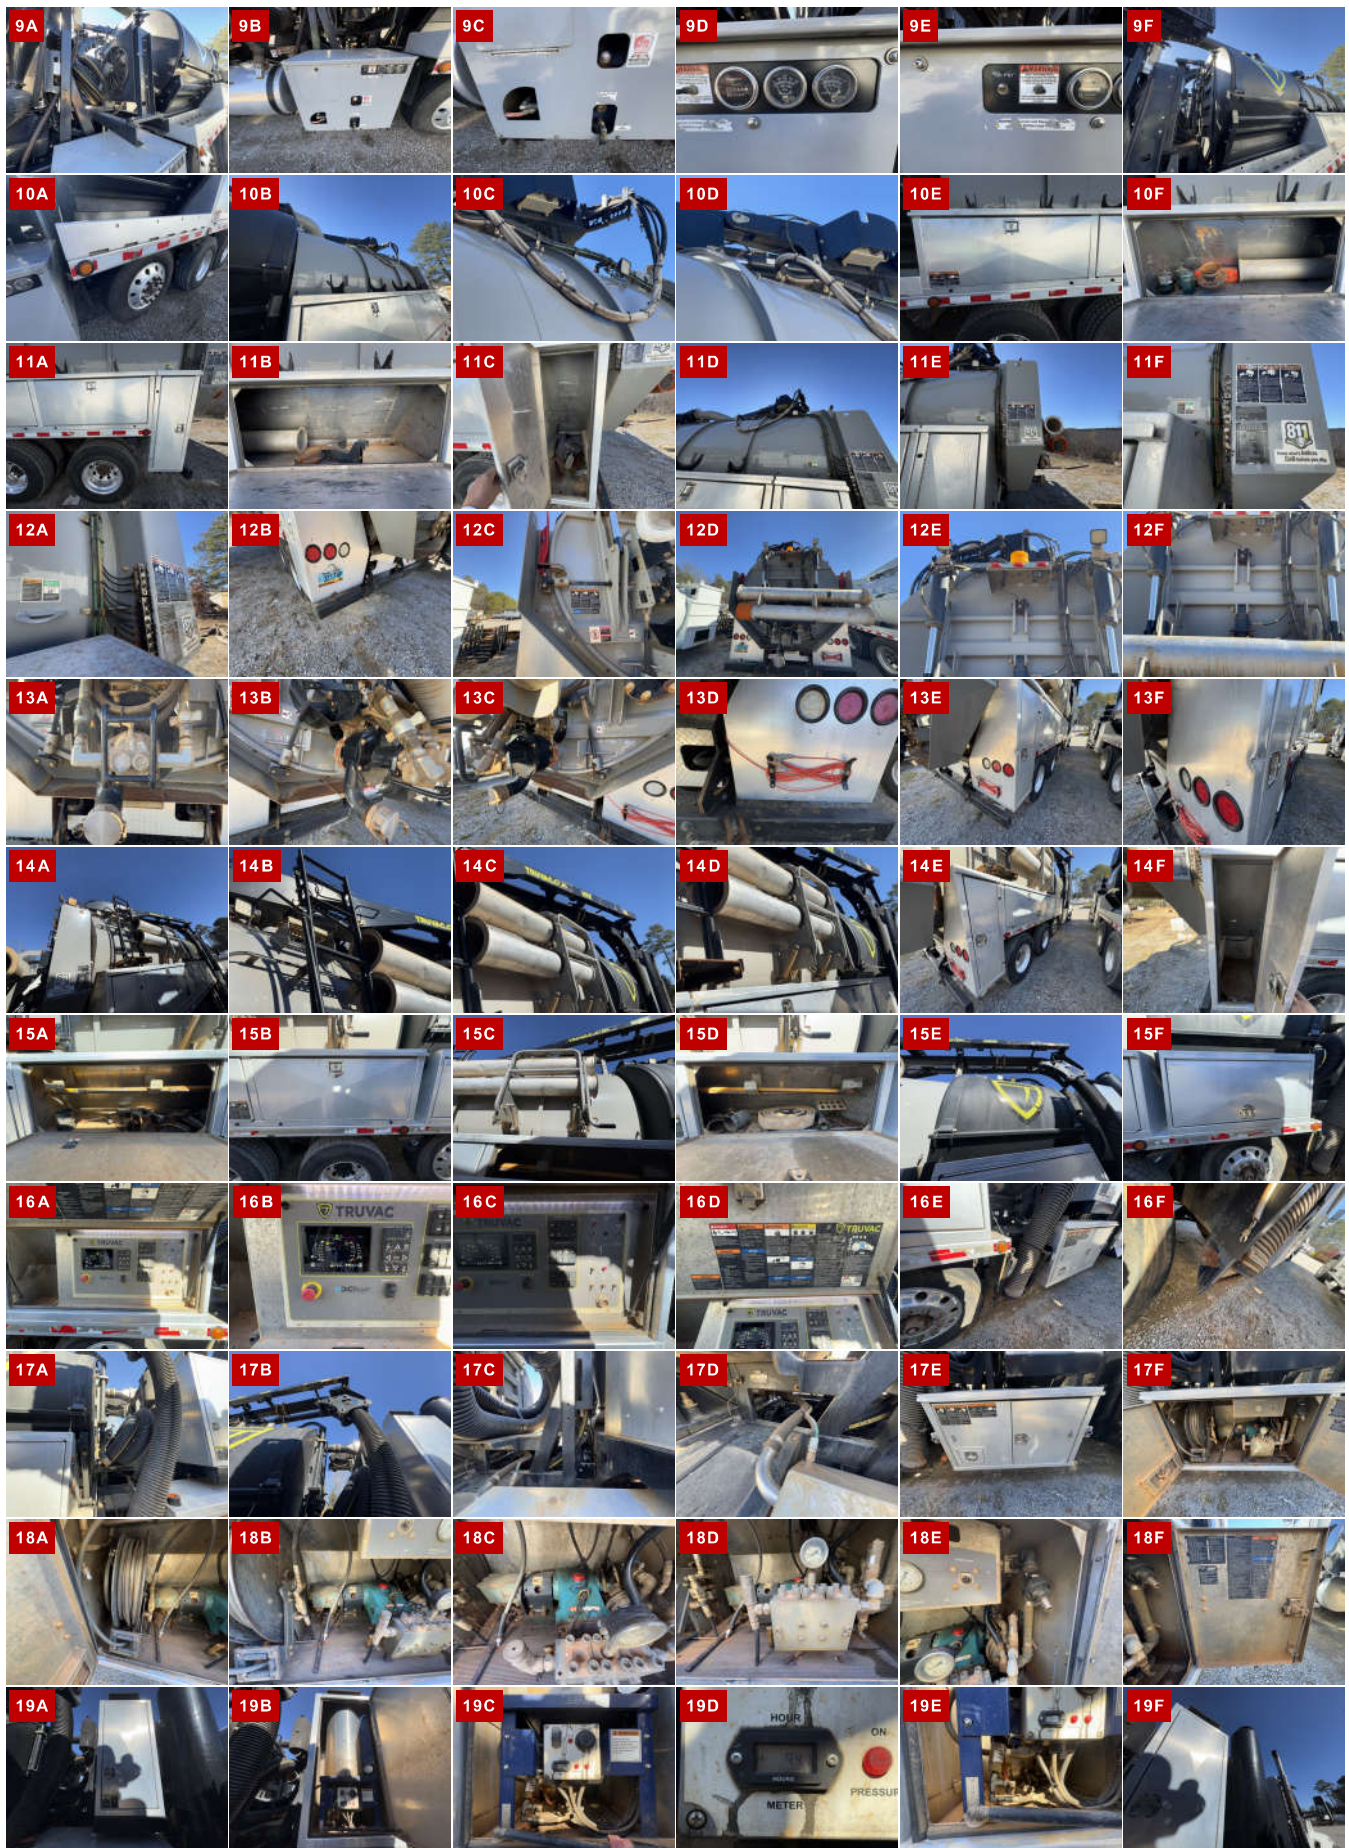
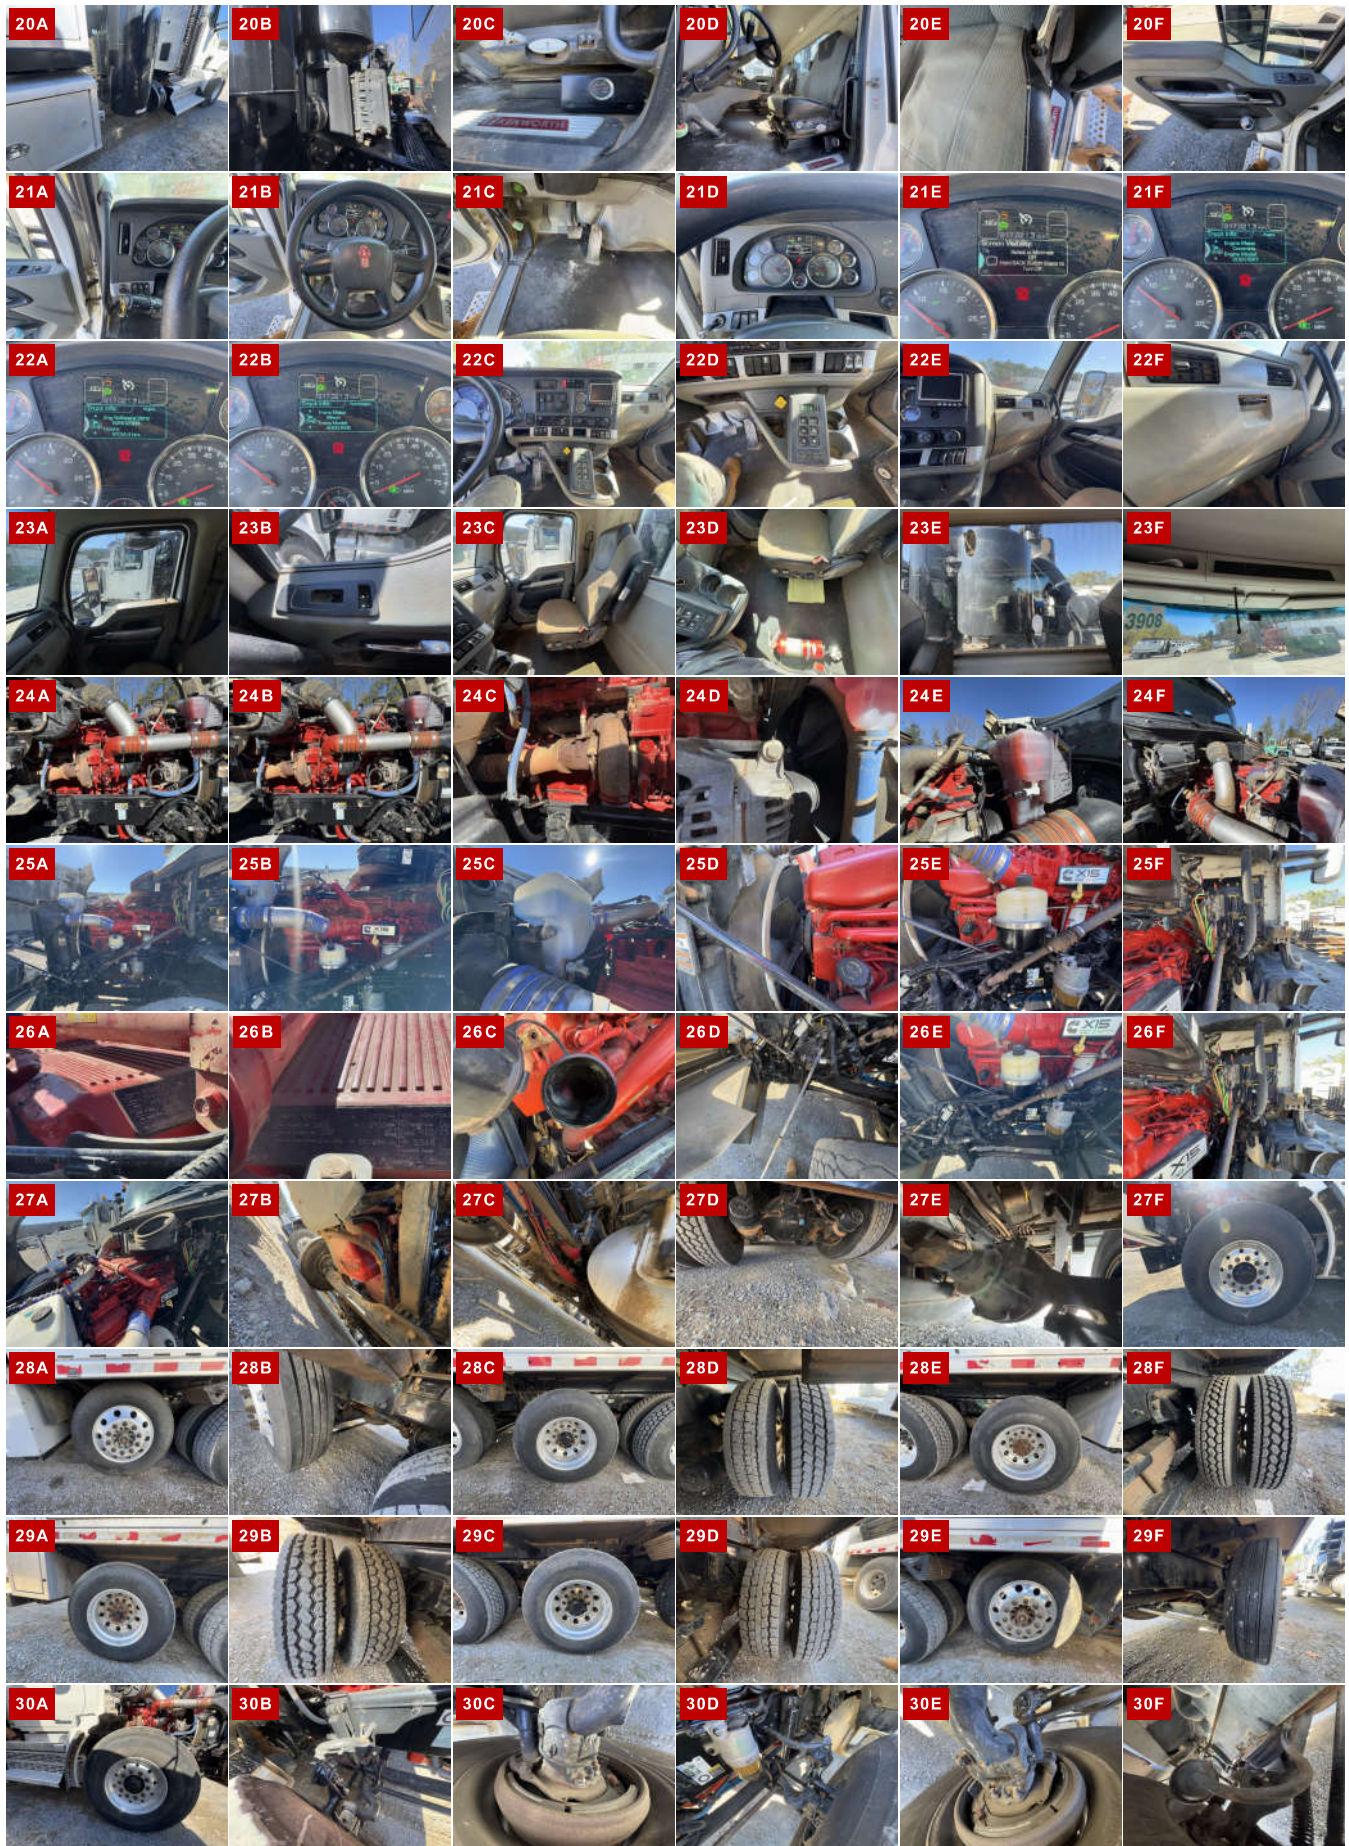
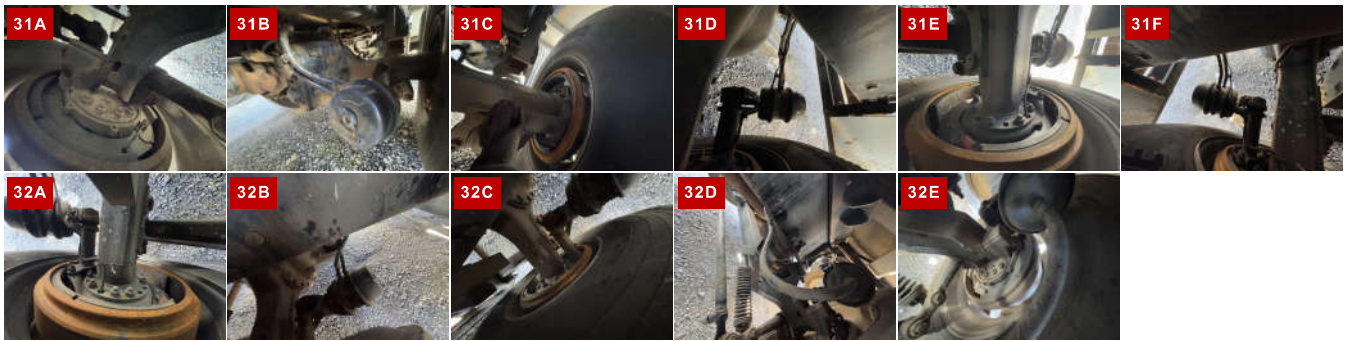
REPORT PHOTOS

WEAR & TEAR DETAIL	
DIAGNOSTIC REPORT	2 ACTIVE FAULTS / 5 INACTIVE FAULTS FOUND - (SEE ECM REPORT)
BUMPER	BENT
STEP	BENT AT BOTTOM ON DRIVER SIDE
PAINT	SCRATCHED IN MULTIPLE SPOTS
SEATS	DRIVER SEAT WILL NOT RISE
WINDOW	PASSENGER WINDOW WONT ROLL DOWN
DOOR	BUTTONS MISSING FROM PASSENGER DOOR
GLOVE BOX	HANDLE MISSING
TIRES	1 WORN BELOW 10/32.
