# National Inspection Services

Report: 284856

VIN: 1NKZX7EX7JJ196935

## 2018 KENWORTH T880

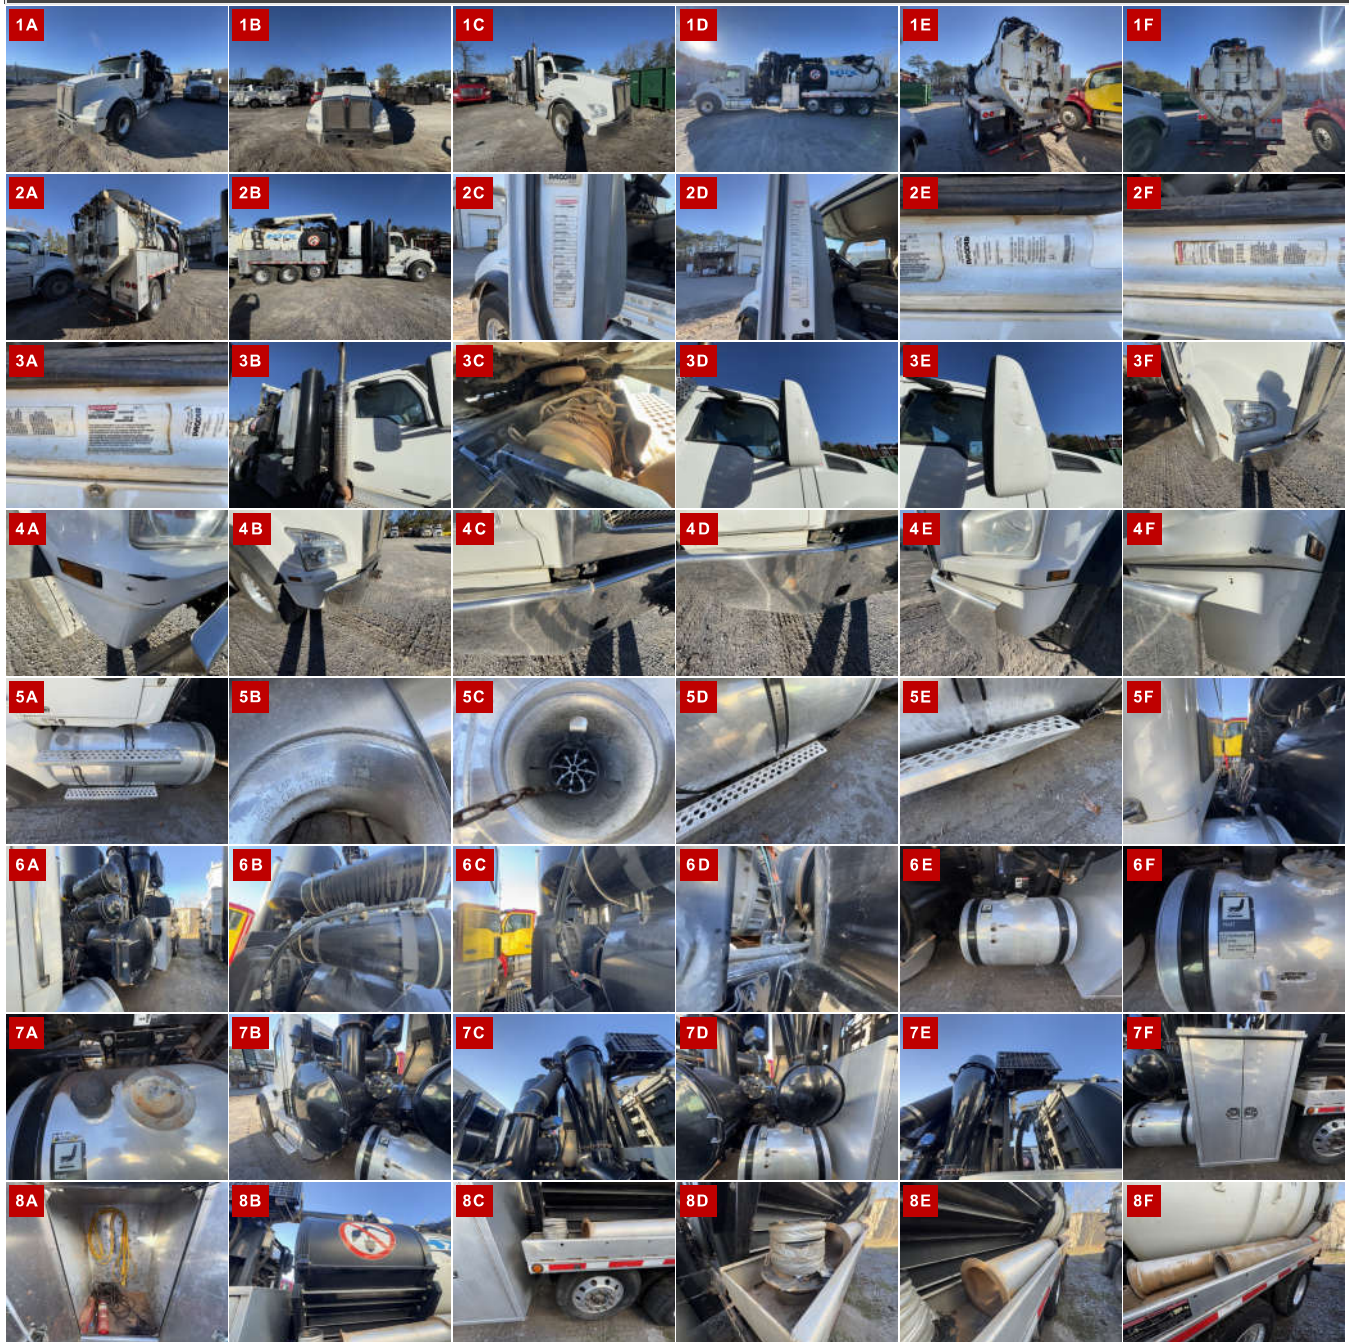
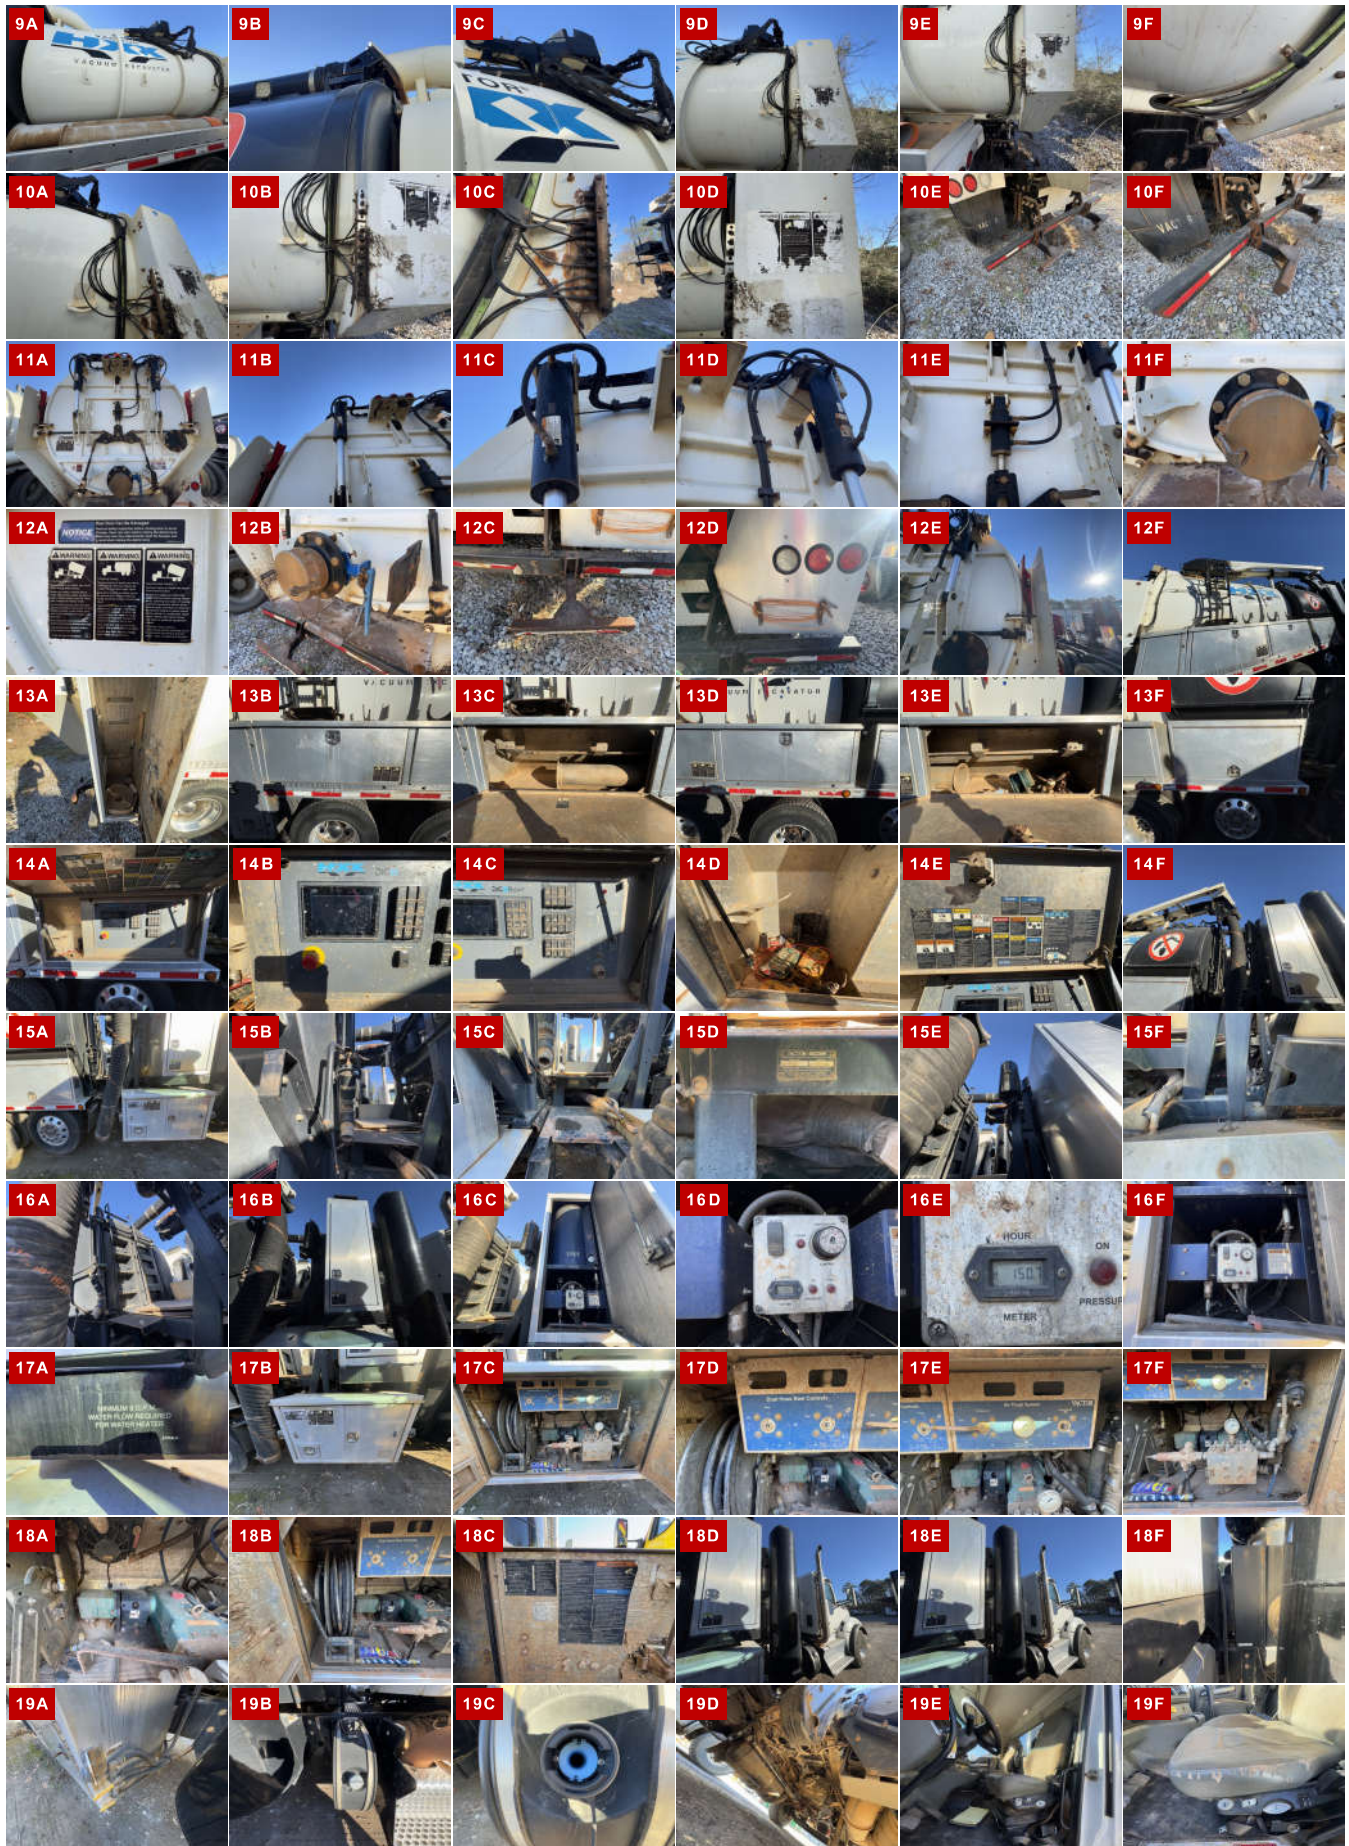
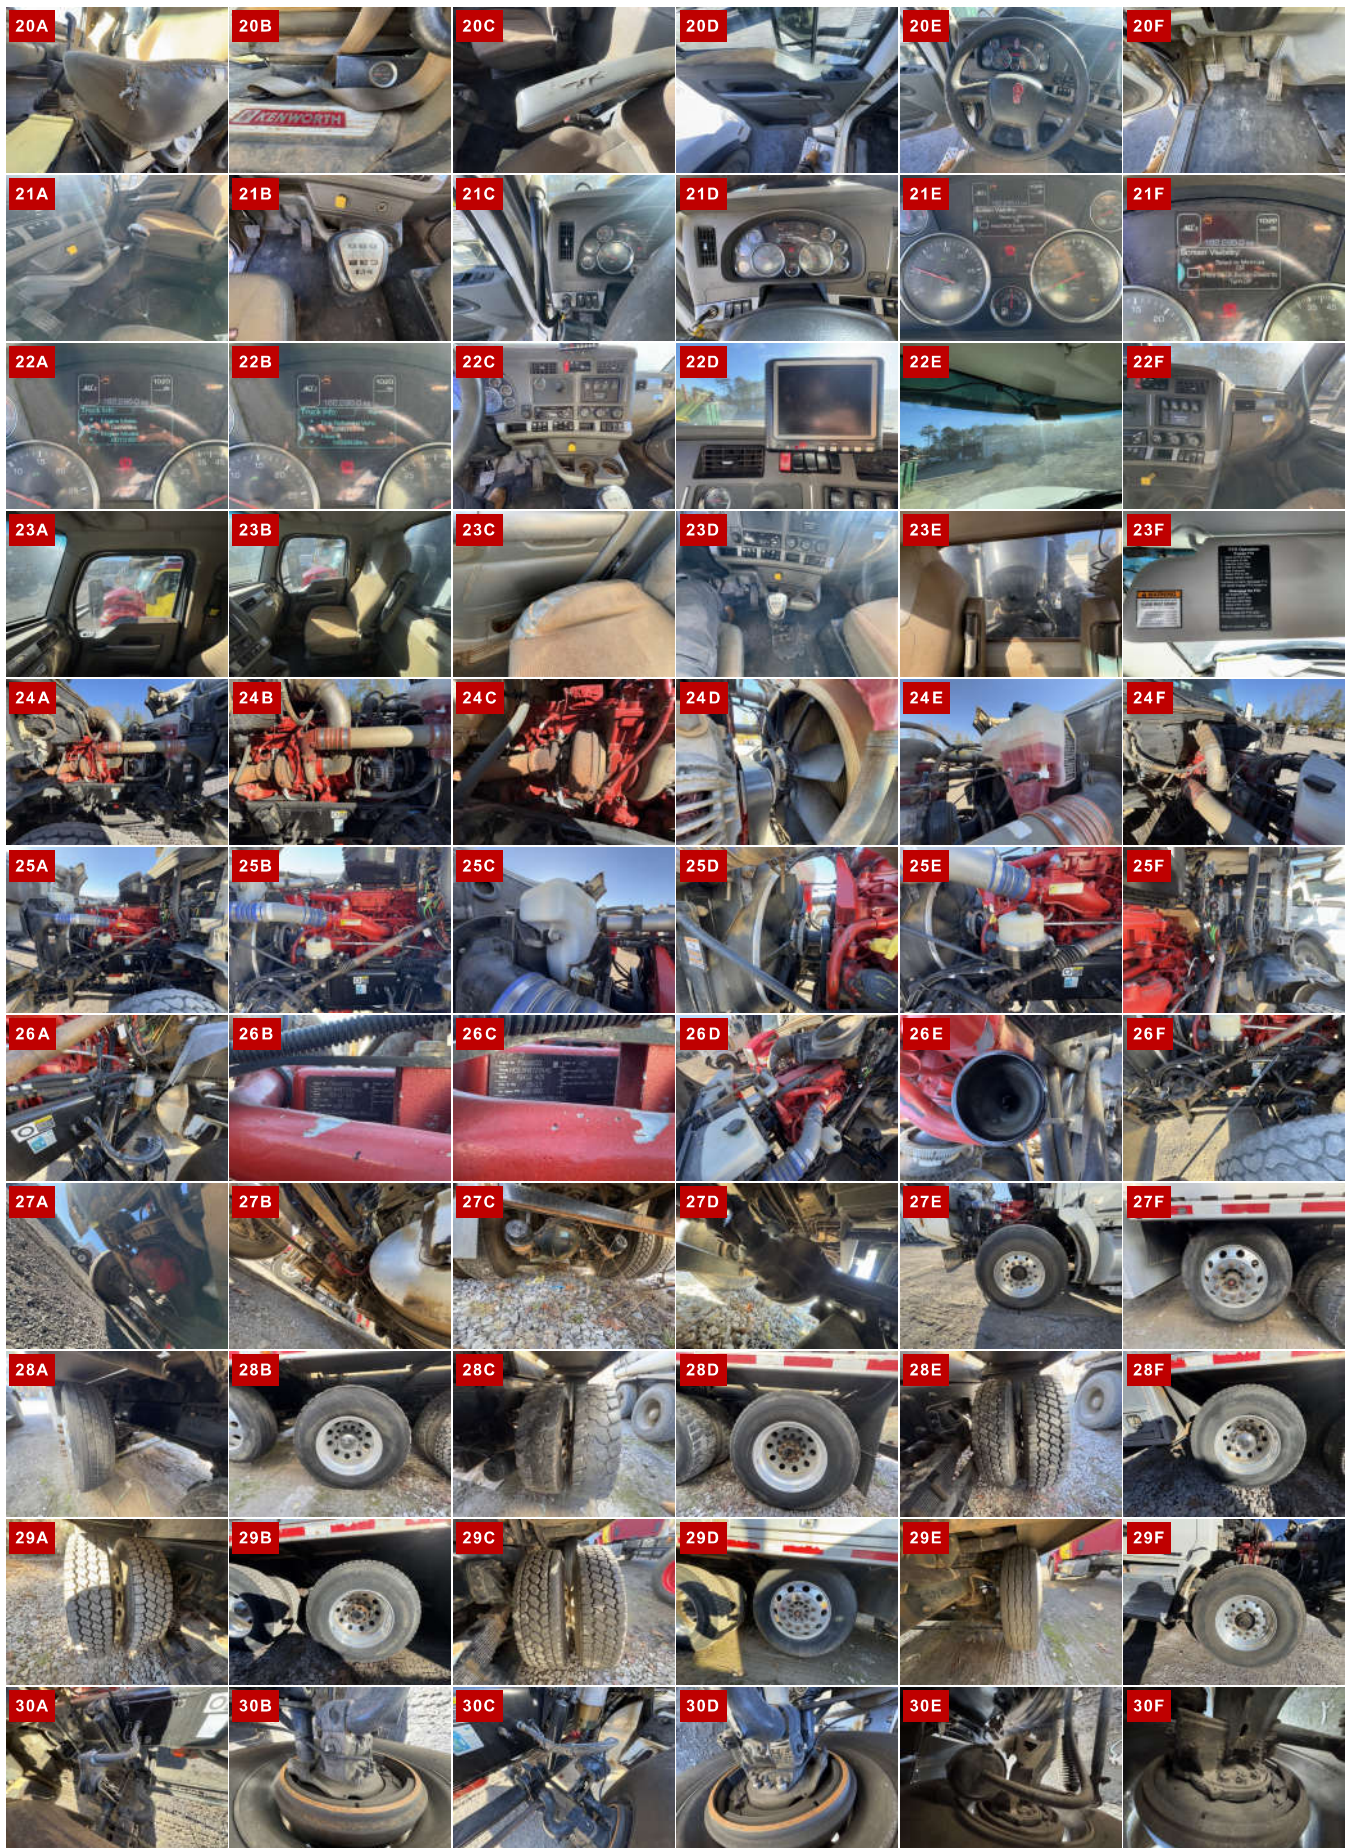
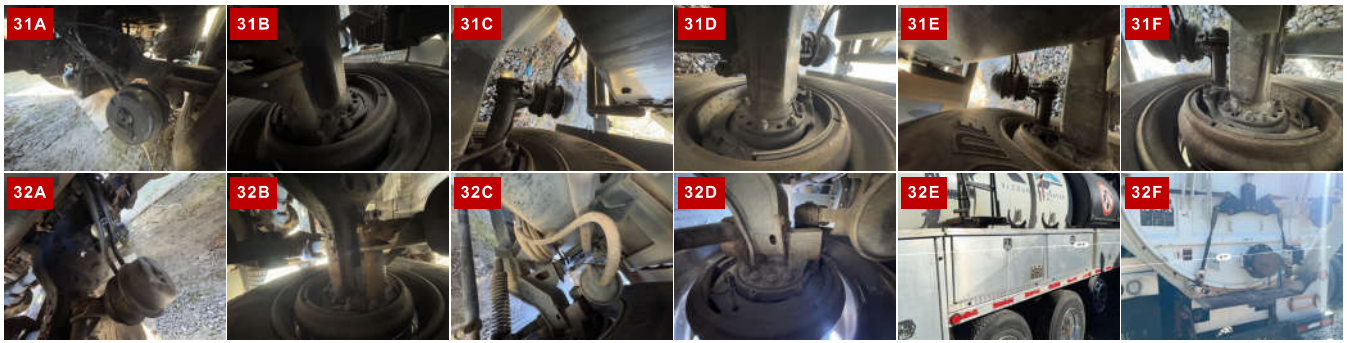
#### REPORT PHOTOS

DPF FAIL: SPN 4340 FMI 3 - AFT 1 SCR CATALYST REAGENT LINE HEATER 1, 2 AND 3. STATE VOLTAGE ABOVE NORMAL, OR SHORTED TO HIGH SOURCE. FRONT AND REAR ENGINE SEALS AND OIL PAN GASKET LEAKING OIL.

DIAGNOSTIC REPORT	CHECK ENGINE LIGHT IS ON. 4 ACTIVE FAULTS / 2 INACTIVE FAULTS FOUND - (SEE ECM REPORT)
BUMPER	BENT ON PASSENGER SIDE
STEPS	BENT AT BOTTOM ON DRIVER SIDE
FRAME	RUSTING IN REAR
MIRRORS	SIDE MIRROR COVER SCRATCHED ON PASSENGER SIDE
SEATS	UPHOLSTERY TORN, STAINED AND WORN.
TIRES	3 TIRES, WORN BELOW 10/32.
