National Inspection Services

Report: 284857
03/19/2025

VIN: 5KKPAEFG4KPKC3773
Stock #: 15191

2019 WESTERN STAR 4900

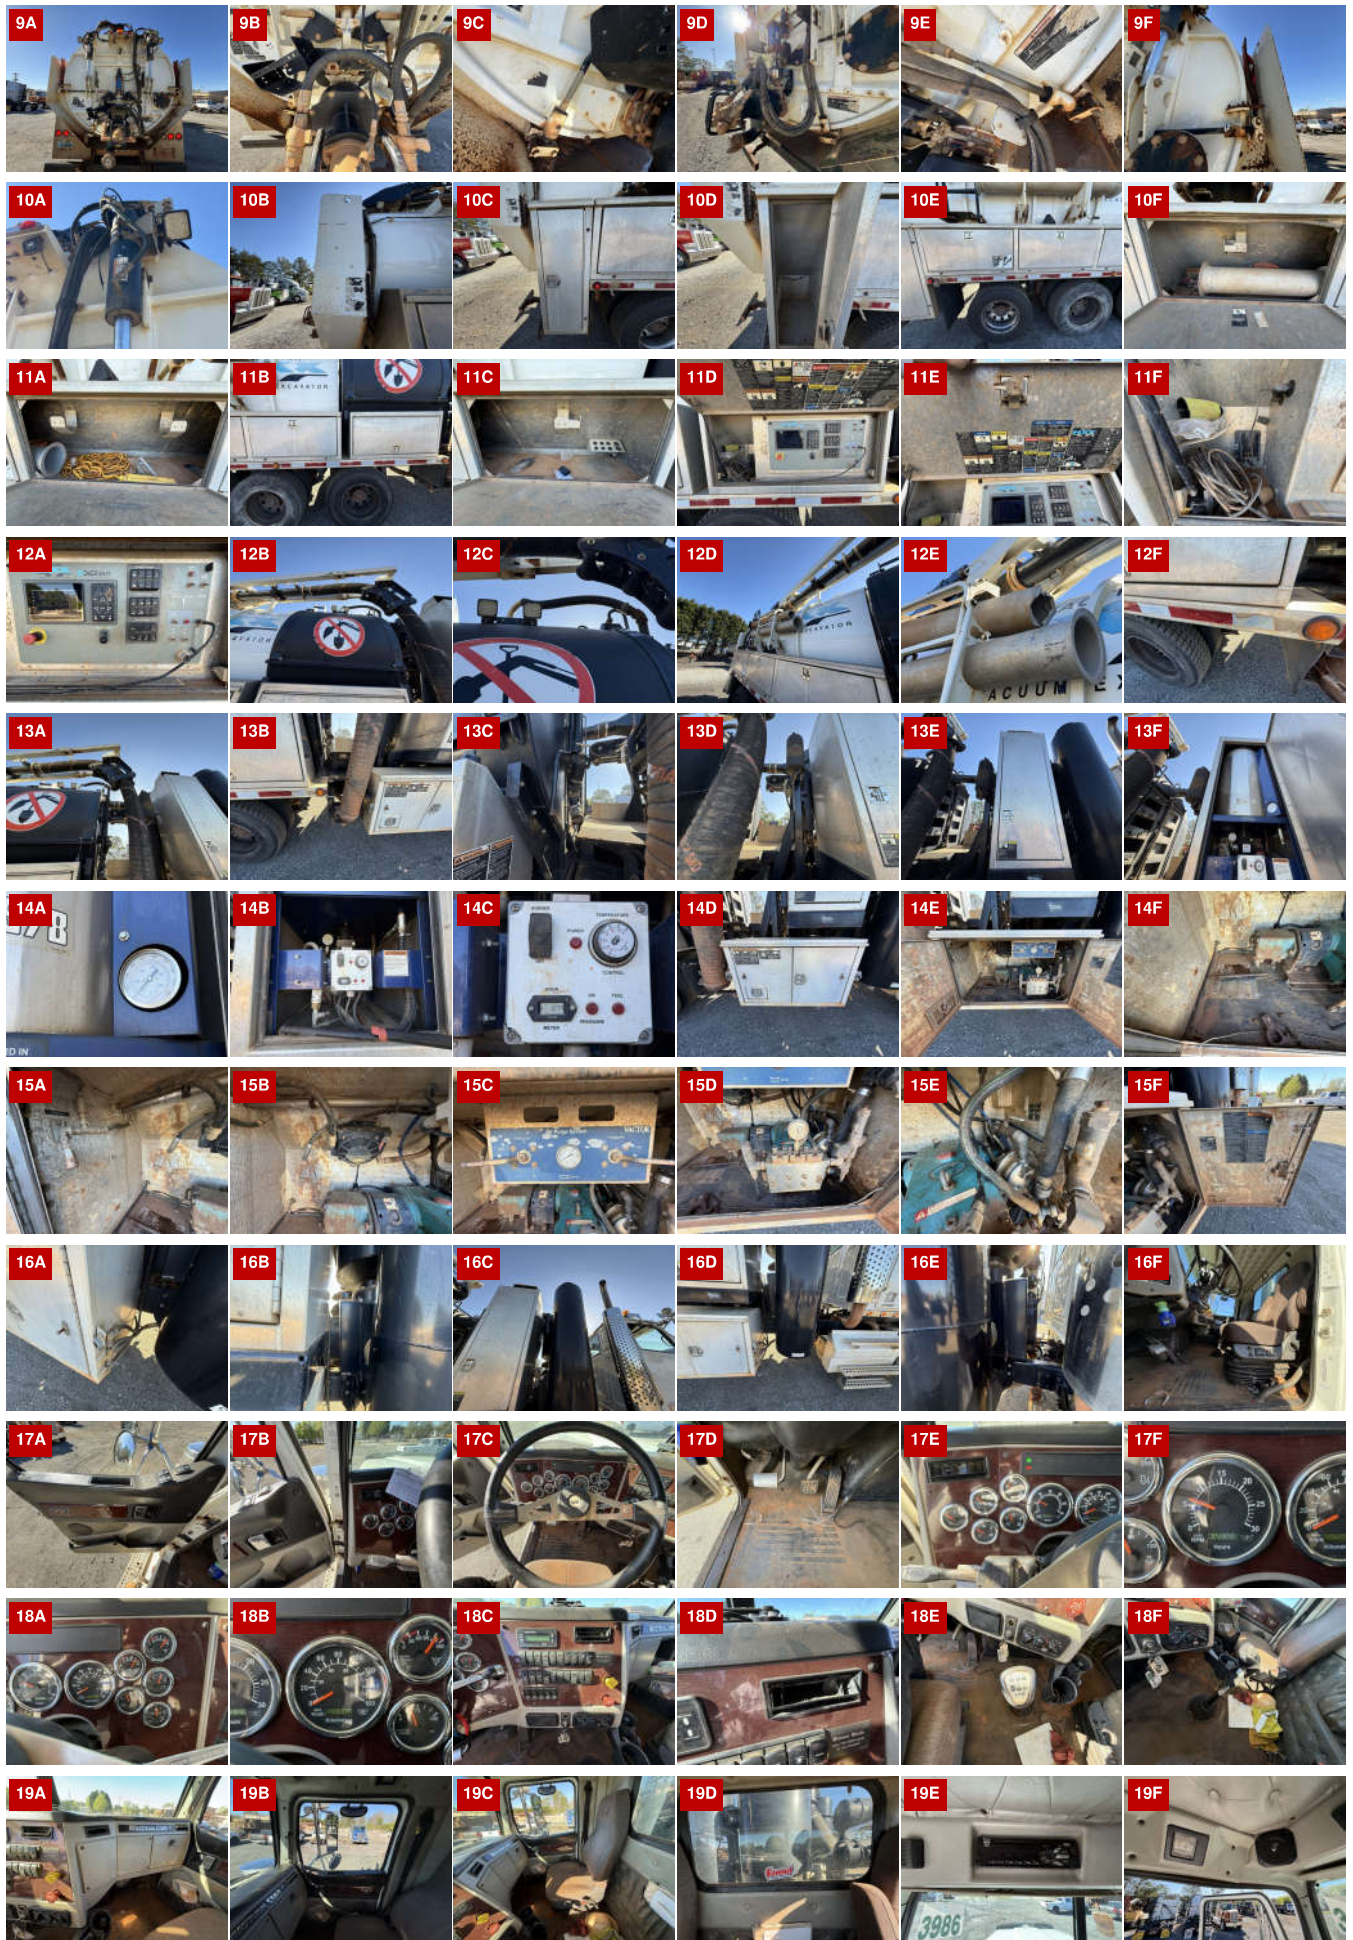
REPORT PHOTOS

ADDITIONAL OBSERVATIONS	
ENGINE OIL PAN IS LEAKING AROUND THE OIL PAN GASKET

WEAR & TEAR DETAIL	
DIAGNOSTICS	NO ACTIVE WARNING INDICATORS
SHOCKS	RUSTED IN REAR
TANKS	HAVE MULTIPLE RUST SPOTS ON BOTH SIDES
BUMPER	P/S CORNER BENT
BREATHER	P/S BREATHER DENTED
HOOD	P/S FENDERS CRACKED AND CHIPPED
DASH	VENT DAMAGED IN THE CENTER OF THE DASH
