National Inspection Services

Report: 284859 01/20/2025

VIN: 5KKPAEFGXKPKS6665

2019 WESTERN STAR TRI DRIVE

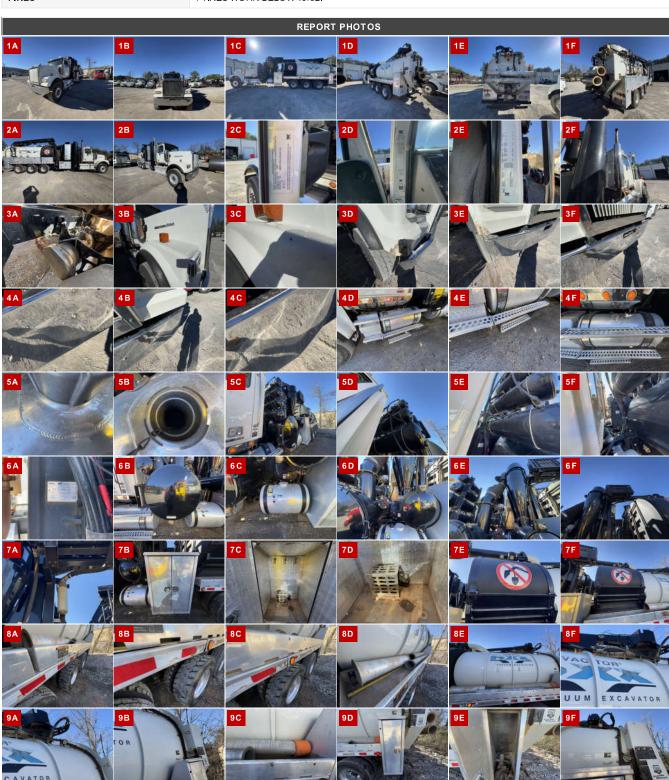
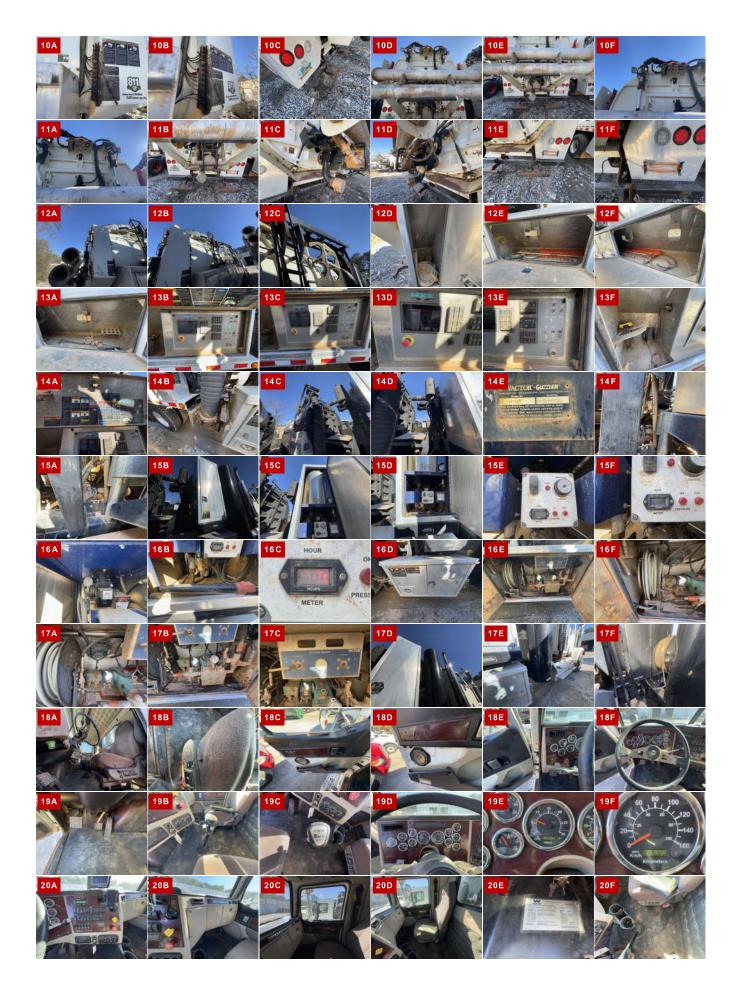
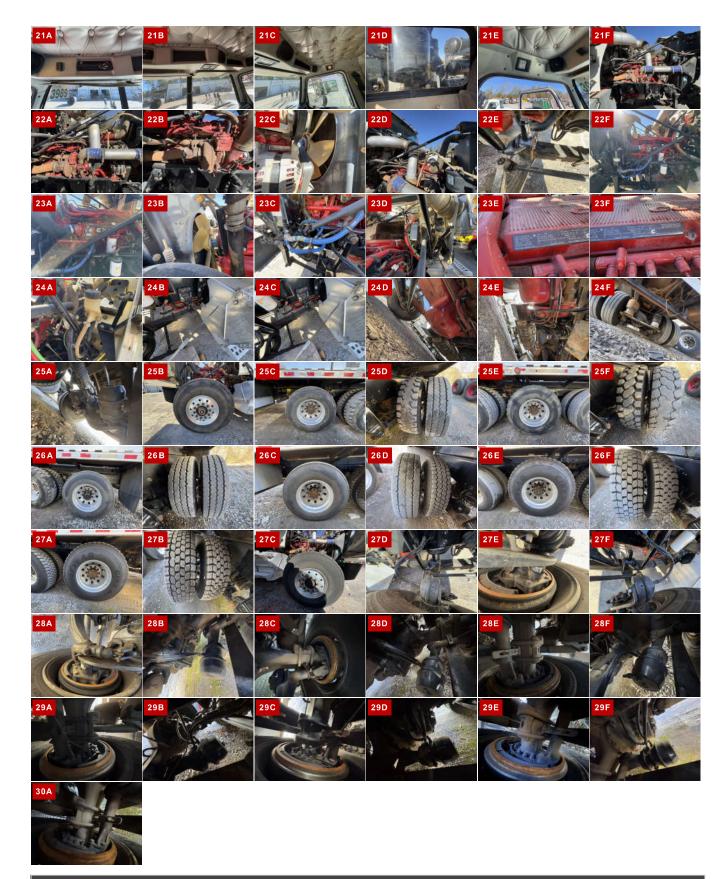
WEAR & TEAR DETAIL				
DIAGNOSTIC REPORT	1 ACTIVE FAULT / 1 INACTIVE FAULT FOUND - (SEE ECM REPORT)			
BUMPER	BENT			
FRAME	RUSTING IN REAR			
PAINT	CHIPPED IN MULTIPLE SPOTS			
SEATS	UPHOLSTERY TORN, STAINED AND WORN.			
TIRES	4 TIRES WORN BELOW 10/32.
